# Standard Troubleshooting Procedures

CalAmp TTU-720, CalAmp LMU-3000, CalAmp TTU-1200, Morey MC-3, JDES MTG

STANDARD TELEMATICS TROUBLESHOOTING

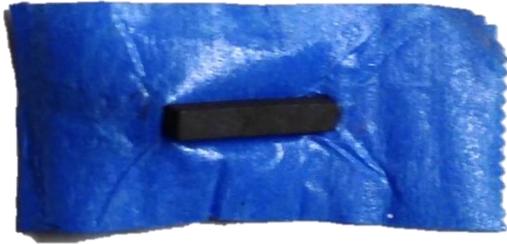
1. Locate the activation magnet that was included in the TTU-720 kit.

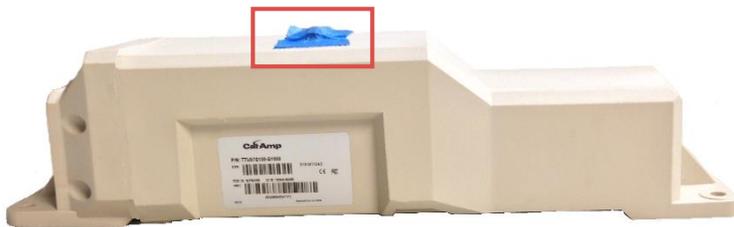
2. Place the activation magnet on the TTU-720 inside the rectangular outline on the topside of the unit for a minimum of 30 seconds.

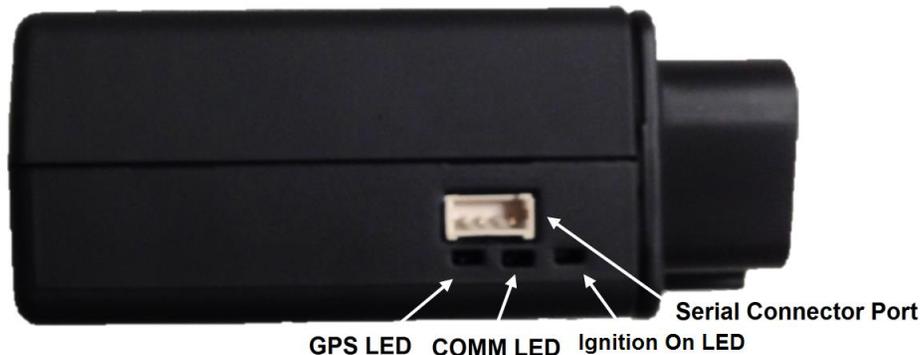
FIGURE 1: CALAMP LMU-3000 LEDs

The CalAmp LMU-3000 telematics control unit is an OBD unit designed for light trucks and passenger cars. The LMU-3000 has three status LEDs for Power, Communication, and GPS states, as shown in Figure 1.

If all Status LEDs are unlit, there might not be power provided to the unit. Make sure the LMU-3000 is securely plugged in to the asset's OBD port, and then turn ignition on. All three LEDs should light up.

If the orange LED is not lit but the green LED is, you have a GPS fix but you have lost cellular signal. Complete the following steps to restore cellular signal.

If the green LED is not lit but the orange LED is, you have cellular signal but you do not have a GPS fix. Complete the following steps to restore a GPS fix.

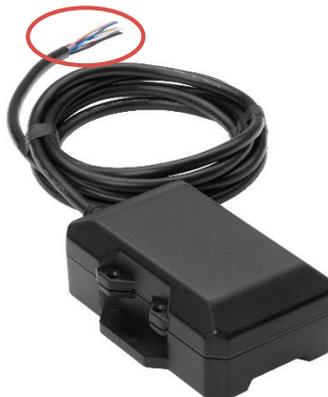
FIGURE 2: CALAMP TTU-1200 WIRING HARNESS

The TTU-1200 is installed on an asset using a three-wire wiring harness, as shown in Figure 2. If the TCU is malfunctioning, the wiring harness may not have been installed properly.

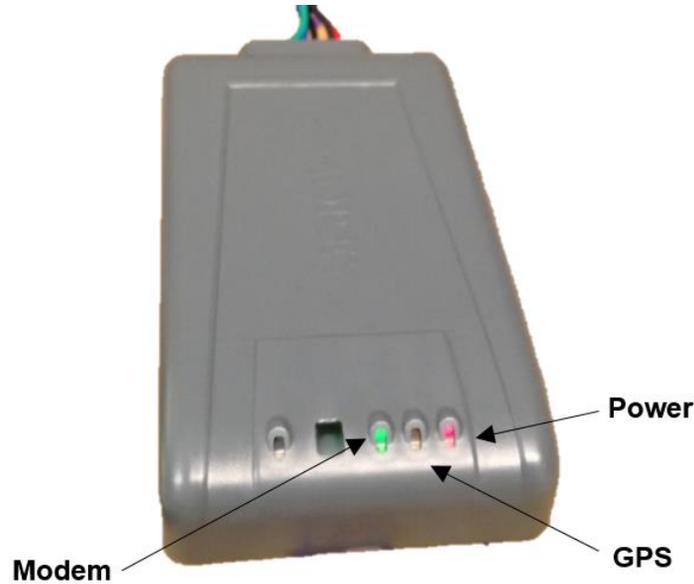
FIGURE 3: MOREY MC-3 STATUS LEDs

The Morey MC-3 a fleet-tracking unit that uses a three-wire, 6-pin, or 9-pin wiring harness to connect to the asset. It also has three status LEDs for monitoring Power, Modem, and GPS Status, as shown in Figure 3.

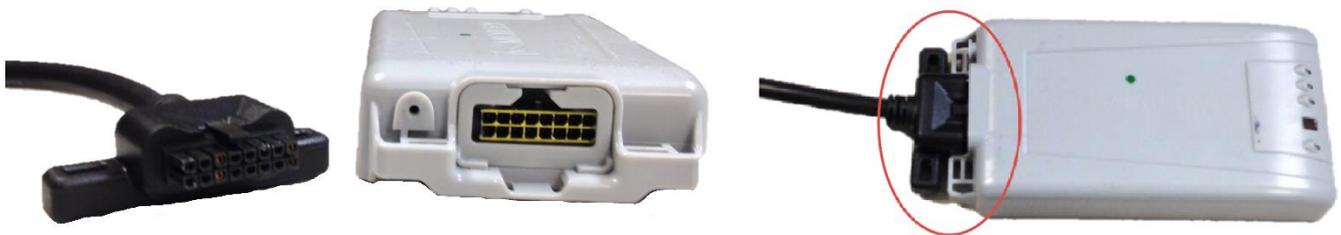
FIGURE 4: T-CONNECTOR AND MC-3

If all LEDs are unlit, the MC-3 is not receiving any power. Make sure that the wiring harness is correctly installed and that the T-Connector is securely plugged in to the MC-3, as shown in Figure 4.

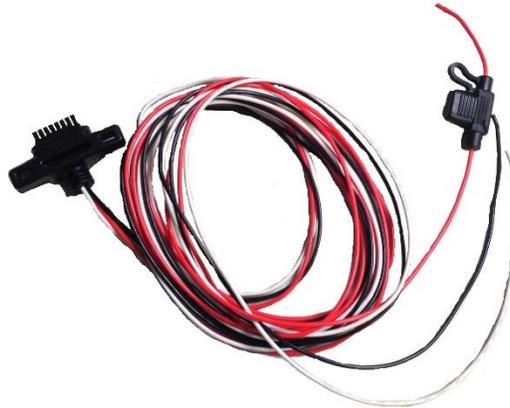
FIGURE 5: MC-3 3-WIRE HARNESS

The MC-3 can be installed on an asset using a three-wire harness, as shown in Figure 5. If the TCU is malfunctioning, the wiring harness may not have been installed properly.
